Navajo Abandoned Uranium Mine

Site Screen Report

Mine Name: Blk022
Mine ID: 404

August 2011

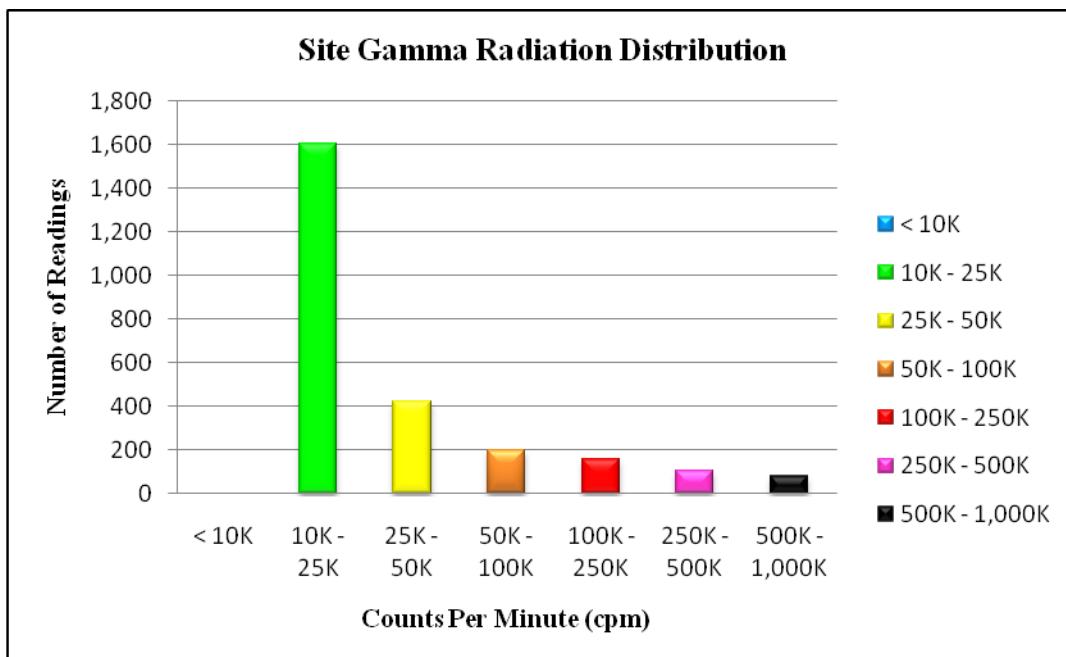
Highest gamma radiation measurement: 809,768 counts per minute (cpm)

Background Average: 13,268 cpm **Two Times Background:** 26,536 cpm

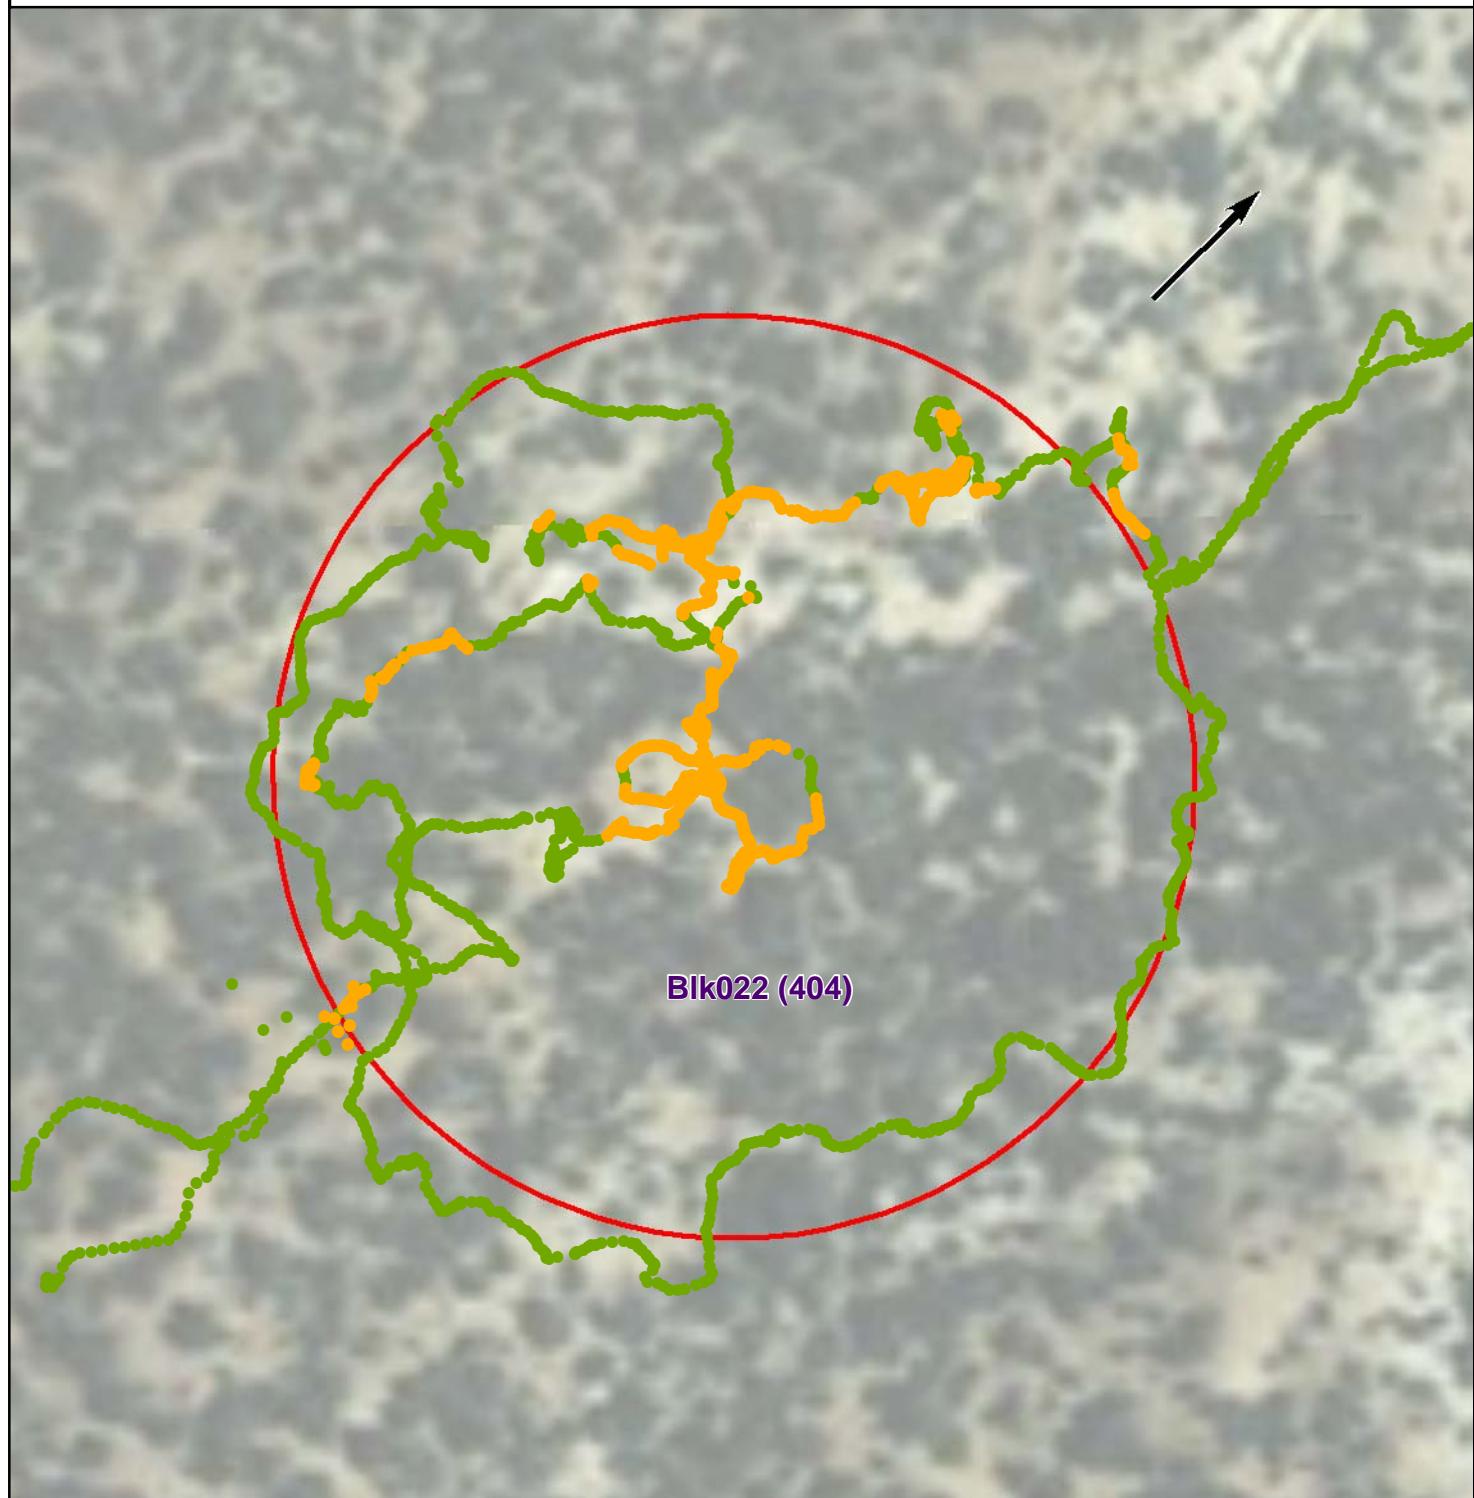
A total of 2,560 gamma radiation measurements were collected from the mine site, ranging from 10,117 cpm to 809,768 cpm. The measurements are represented in Figures 1 and 2.

Figure 1 - Gamma Radiation Measurements, Above Two Times Background
Blk022 (404)
Tselani Chapter, Navajo Nation

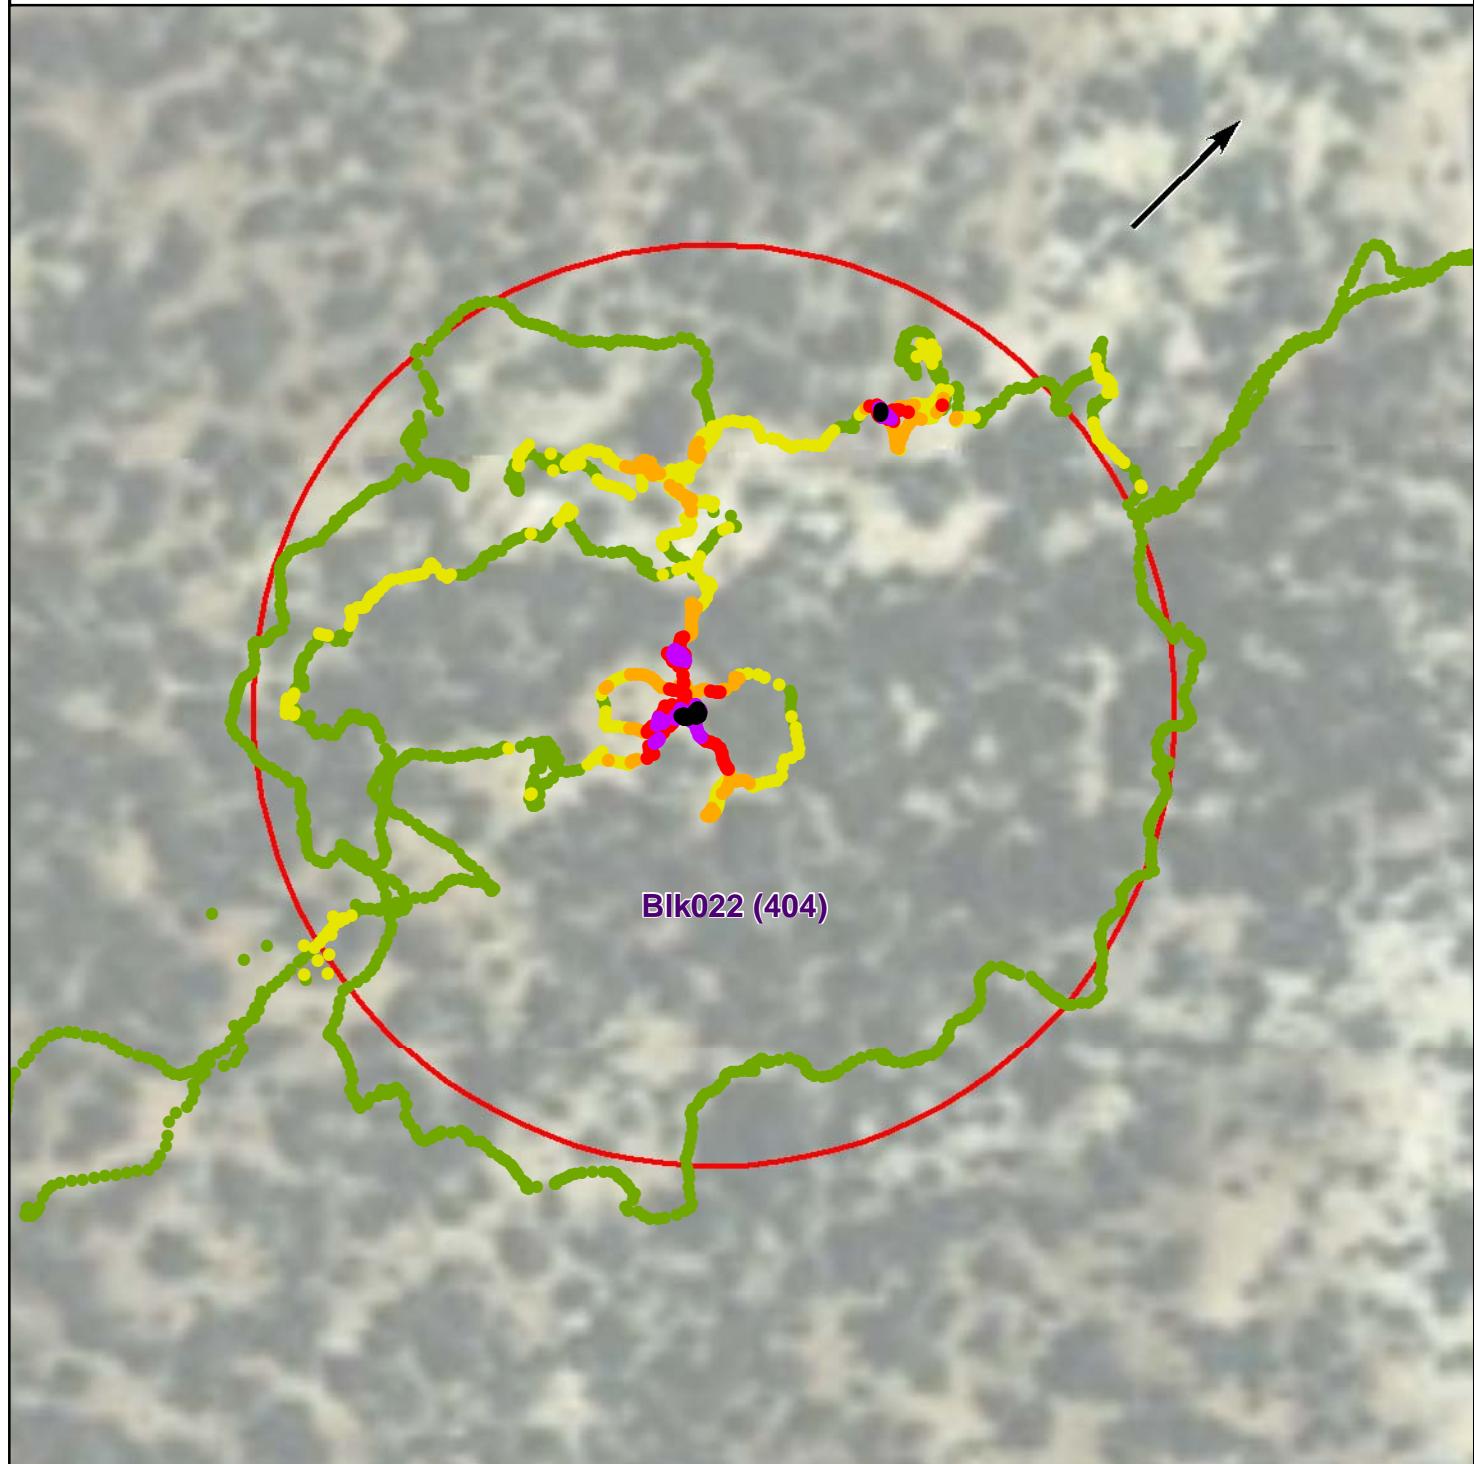
Figure 2 - Gamma Radiation Measurements
Blk022 (404)
Tselani Chapter, Navajo Nation
